Product Bulletin No.: D99-RRV2015-PIB-001

Titan 'BX' Automatic Pressure Relief Valves

Issue Date: April 22, 2016

- Subject:** Structural failure of a Titan Type BX pneumatically-operated pressure relief valve, and required upgrade, periodic inspection, testing, and maintenance of such valves.

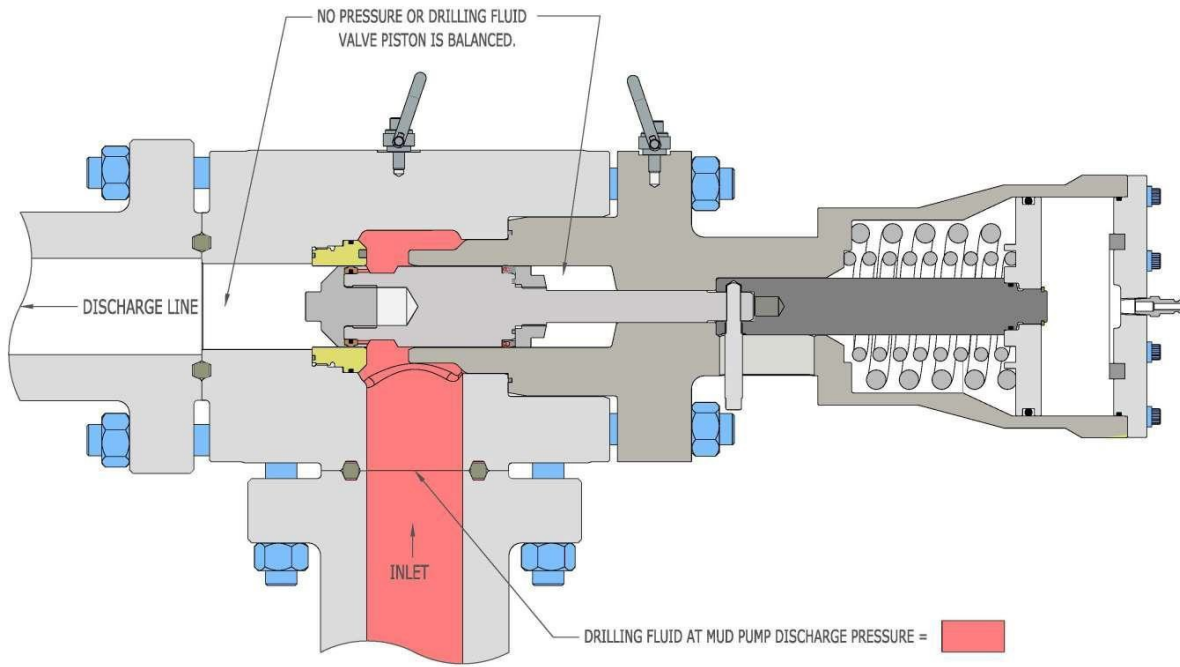
Figure 1: BX Valve Normal Operation:

Figure 1 shows the normal operating mode, with mud and mud line pressure shaded red. Figure 2 shows the intrusion of mud above the valve piston that can occur if the upper piston seal allows substantial leakage. Specific locations to monitor for leakage of the upper piston seal are also shown in Figure 2:

The Titan BX relief valve is designed to be pressure-balanced, with no pressure above the valve piston. If leakage of the valve piston upper seal occurs and continues unchecked, it is possible for drilling mud volume and/or pressure to build above the valve piston. This could prevent the valve piston from opening to relieve pressure at the intended relief pressure.

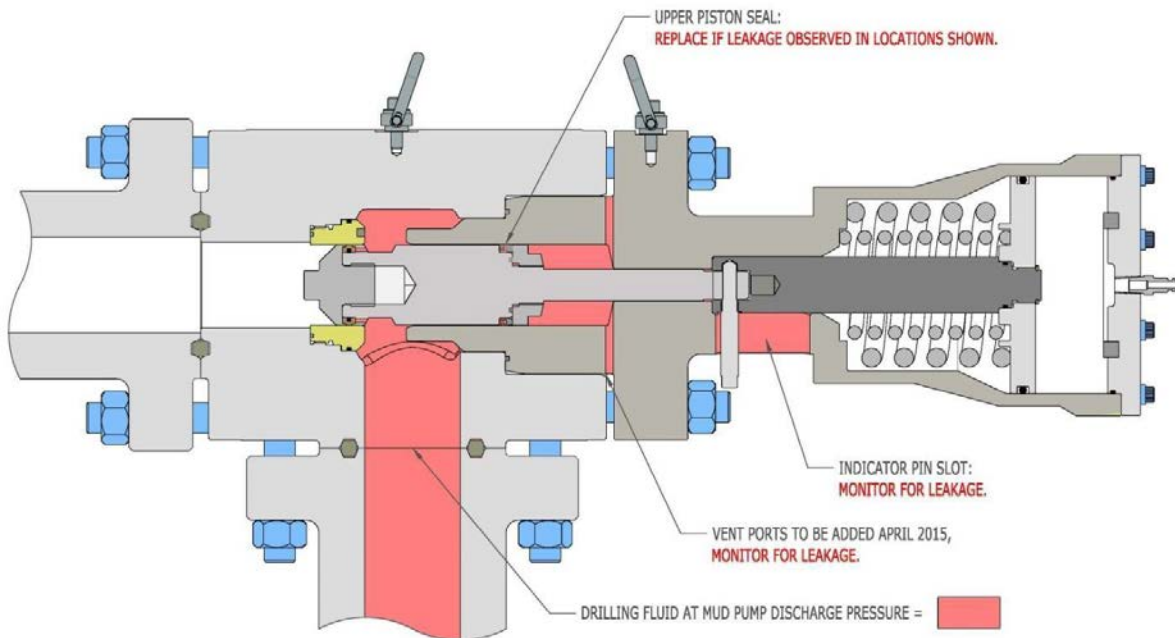
Figure 2: BX Valve Potential Leakage and Inspection Locations:

As a result of its investigation of the incident, NOV has determined that the upper piston seal failed, allowing drilling mud to pass by it. Unbalanced pressure on the top of the valve piston sheared the stem portion at the pin connection hole. NOV is recommending both (1) visual inspection and (2) preventative maintenance of all Titan 'BX' relief valves as described below.

The Titan BX relief valve should be visually inspected every seven (7) days as a minimum for external evidence of leakage. **If the upper seals on the valve piston becomes damaged or badly worn, and continuous leakage occurs, the valve may not function properly to relieve pressure.**

- a) For all Titan BX valves leakage of drilling fluid from the slot for the position indicator pin is indicative of leakage of the valve piston upper seal.

- b) Titan BX valves manufactured after April 1, 2015 will have ports located just below the bonnet flange to improve venting of fluid and pressure that leaks past the valve piston upper seal. Leakage of drilling fluid visible at the gap between the valve body and bonnet flange is indicative of leakage of the valve piston upper seal.

- c) If leakage of the valve piston upper seal is indicated as described above, immediate action must be taken to repair or replace the valve and eliminate the leak.

- d) Existing Titan BX valves will have the vent ports added when returned to an NOV facility for inspection, seal replacement, and OEM repairs. (See Table 1). If the vent ports have not been added, then the NOV safety clamp (NOV P/N: 51027708) must be installed on the actuator.

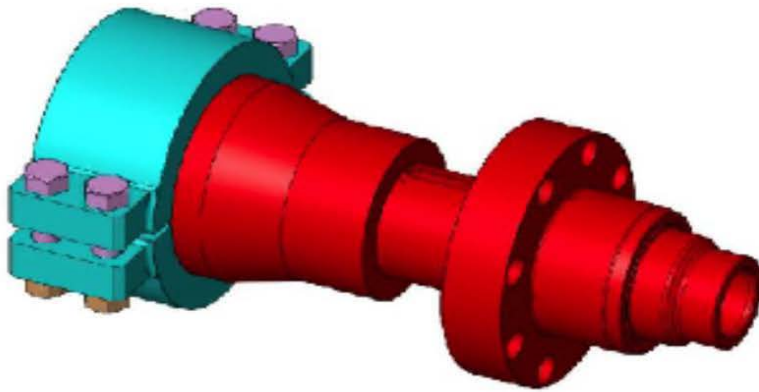
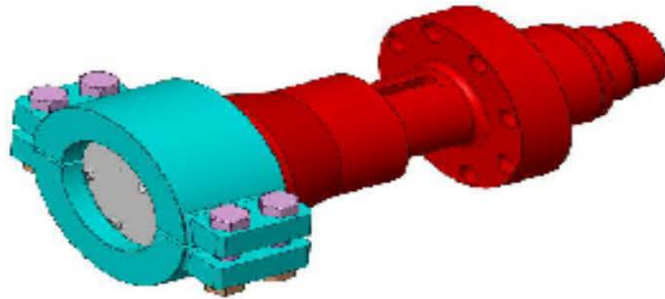
FIGURE 4

Safety Clamp Installed

*In the event that a valve cannot be brought in for the 12 month maintenance NOV recommends using a safety clamp on the actuator (NOV P/N: 51027708) until the valve can be taken out of service to drill the vent holes.
(See figure 4 for clamp installation)*

Note: Safety Clamps are to be installed per the NOV Titan BX Safety Clamp Installation Procedure 51029090-SPC.
