# SAFETY ALERT

Safety Alert No.: D99-RRV2015-SA-001

**Titan BX Pressure Relief Valve**

**Date:** August 7, 2015

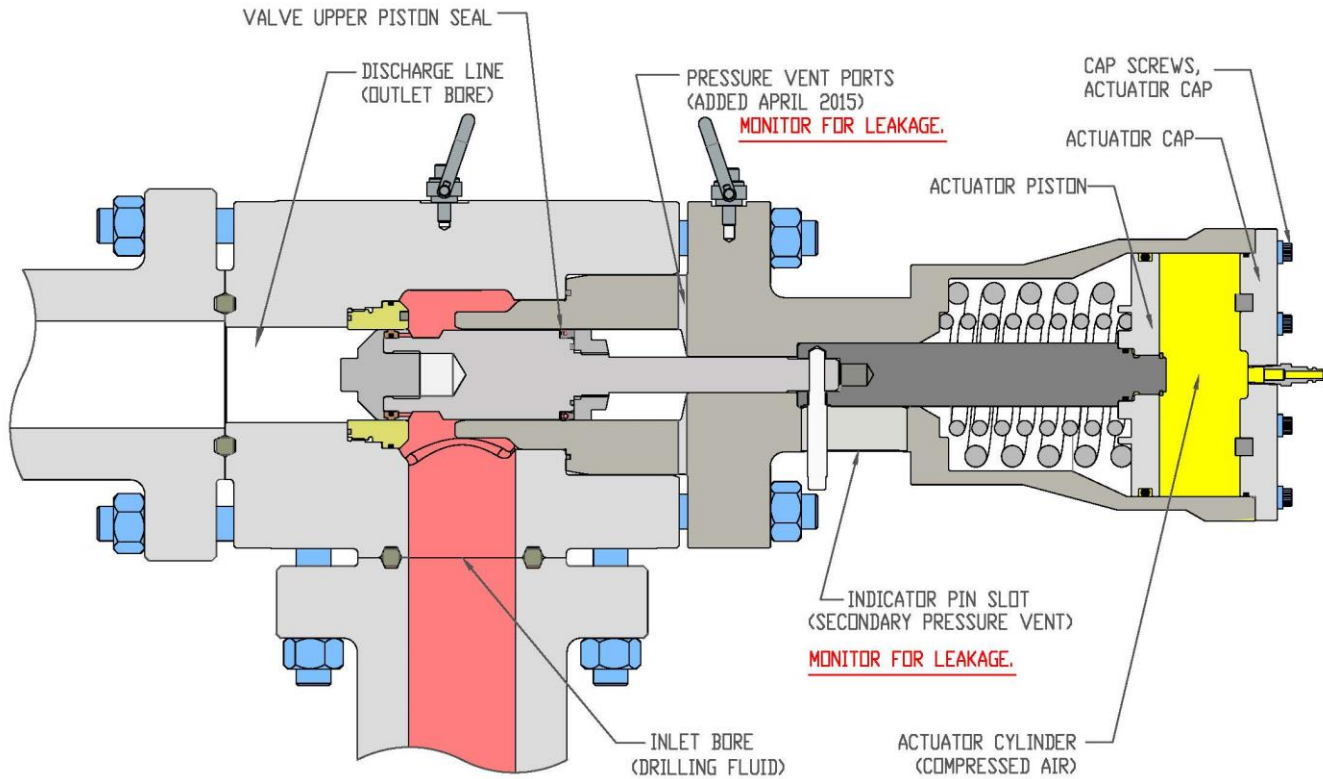
**Figure 1: Titan BX Valve and Actuator:**

Specific locations to monitor for leakage of the upper piston seal are shown in Figure 1:

- a) For all Titan BX valves, leakage of drilling fluid from the slot for the position indicator pin indicates leakage of the valve piston upper seal.
- b) Titan BX valves manufactured after April 1, 2015 have four ports located just below the bonnet flange to improve venting of fluid and pressure that leaks past the valve piston upper seal.

NOV recommends that owners of existing Titan BX valves manufactured prior to April 1, 2015 contact NOV to have the vent ports added. The vent ports are shown in Figure 1 and described above in part 1.b).
